Subject: Incomplete Reclamation, H & H Stone, Little Indian Mine, M0370117, San Juan County, Utah

Inspection Report Minerals Regulatory Program

Mine Name: Little Indian
Operator Name: H & H Stone

Permit number: M0370117
Inspection Date: June 13, 2006
Time: 4:35-4:50 PM

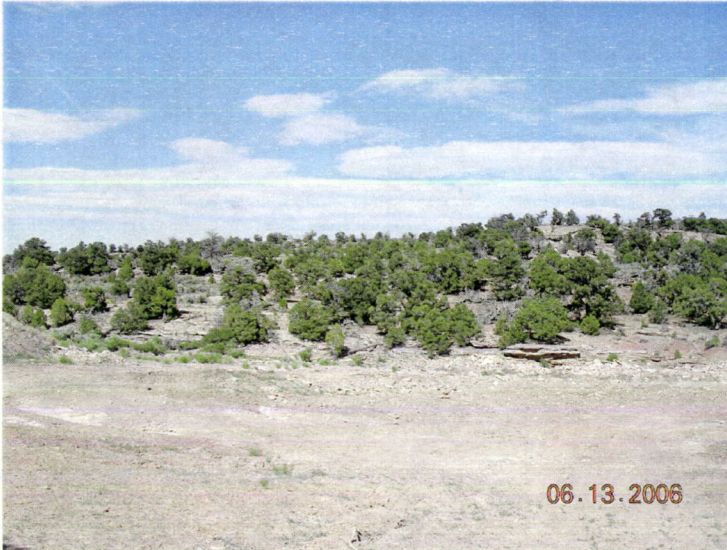
The mine site has little relief, and most of the area has been graded to blend with surrounding areas (Photo 1). On the north and east sides of the area, however, there are overburden or soil piles that were not graded (Photos 2 and 3). I do not know why this was not done; I am fairly confident these piles were made as part of the mining operation. This seems to be verified by pictures I took in 2003 (Photos 6-7).

Photo 1. An overview of a portion of the site.

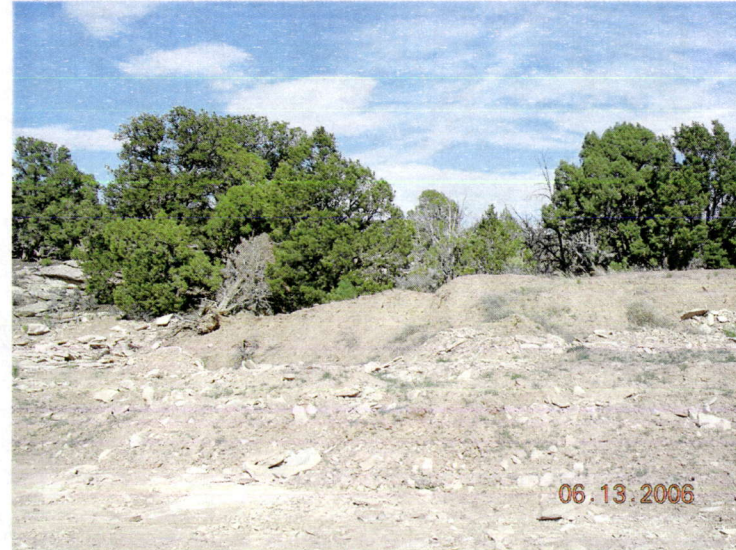
Photo 3. Overburden or soil piles on the west side of the mine.

The operator needs to finish grading and seeding the site.

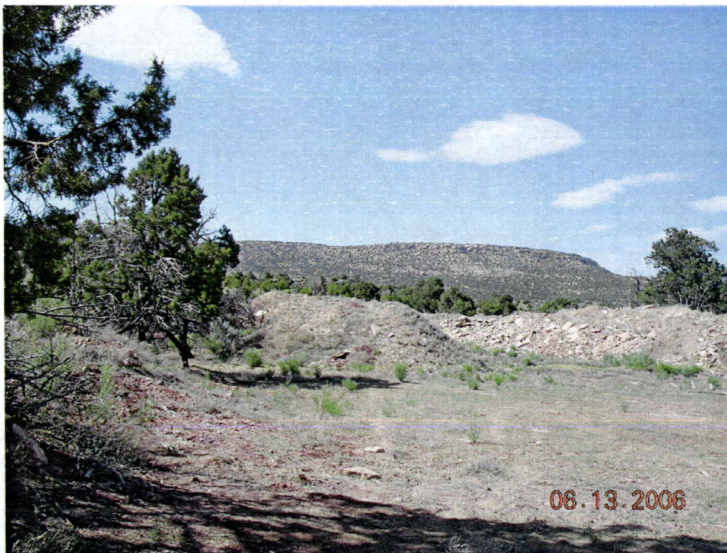
Photo 2. Overburden or soil piles on the north side of the mine.

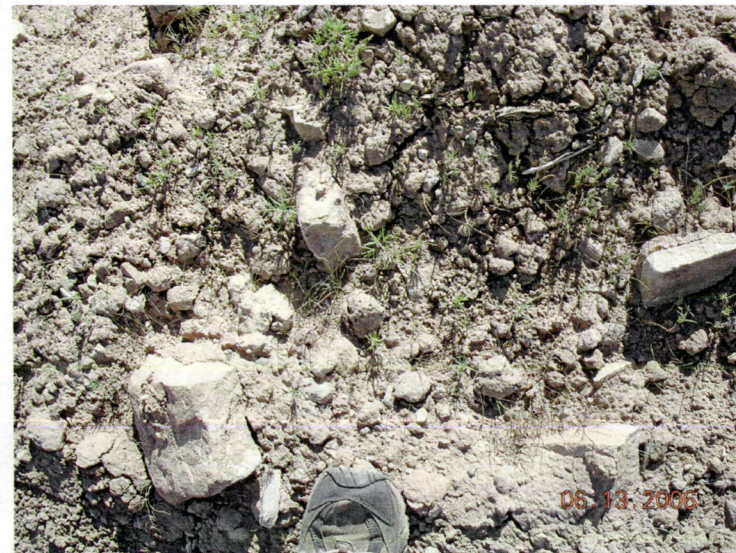
Vegetation appeared to be coming in very well. I found seedlings everywhere there was soil (Photos 4 and 5). As one would expect, there are also lots of weeds, but the weeds I found are not noxious or overly competitive. I fully expect good vegetation cover within a few years in those areas that were graded and seeded.

Photo 4. Perennial vegetation had germinated and was progressing well although there were some weeds.

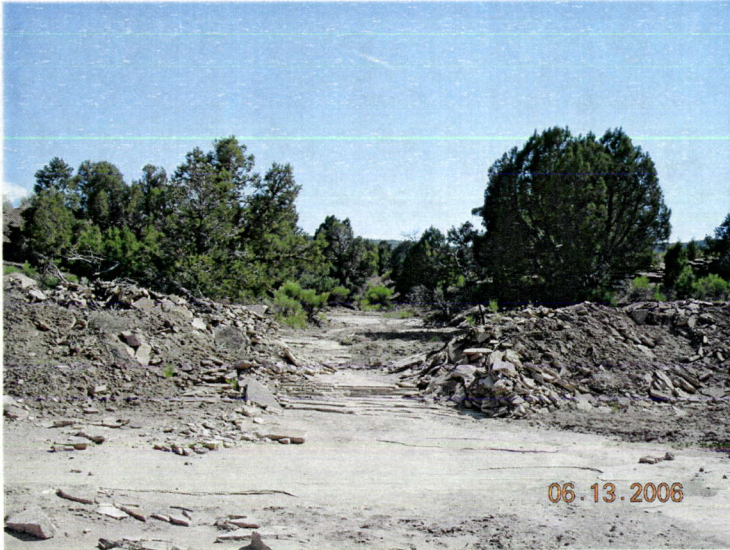
A small impoundment had been created just upstream from the mine, and it has now been breached. I would rather that the operator had spread material from the dam over nearby areas, but I am not terribly concerned how this was done.

Photo 5. This is where the main drainage comes into the mine area from the southwest side of the quarry. The dam was breached, but material was not spread out.

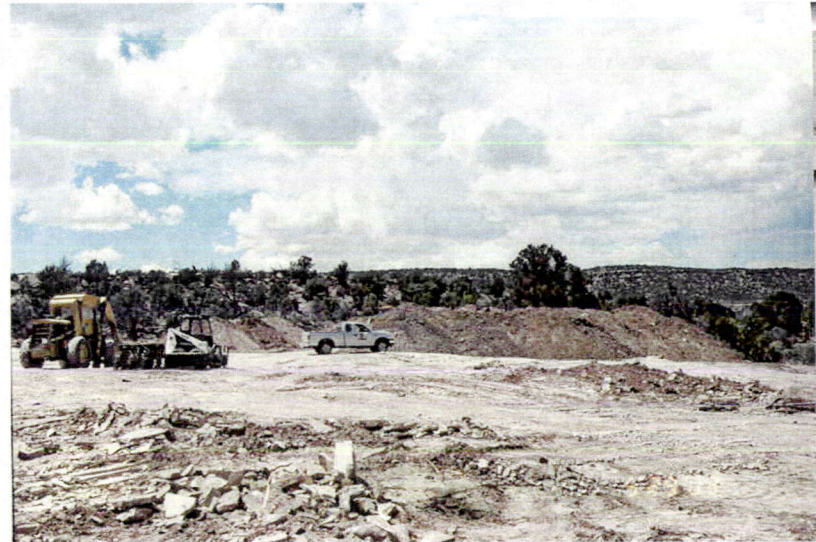
Photo 6. This and Photo 7 show soil/overburden piles in 2003. This all appears to be fresh disturbance.
